Visual inspection and plastic removal system for cleaner cotton

■ By Greg Holt, Research Leader, USDA-ARS Cotton Production and Processing Research Unit, Lubbock, Texas

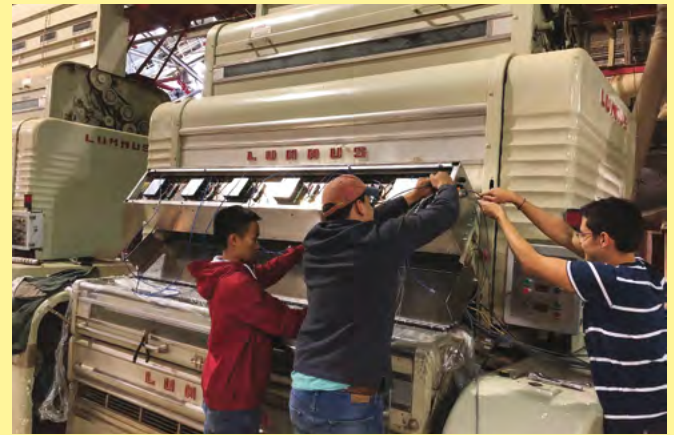
FIGURE 1: (a) Installation of cameras and lighting modules above the feeder apron used in the VIPR (Visual Inspection and Plastic Removal) system

The detection and removal system, known as VIPR (Visual Inspection and Plastic Removal) system, utilises low-cost color cameras, to see plastic on the feeder apron, and an air knife at the bottom of the feeder apron to create a powerful blast of air that ejects the plastic out of the flow of seed cotton, over the front of the gin stand, and onto the floor (Figures 1a and b).

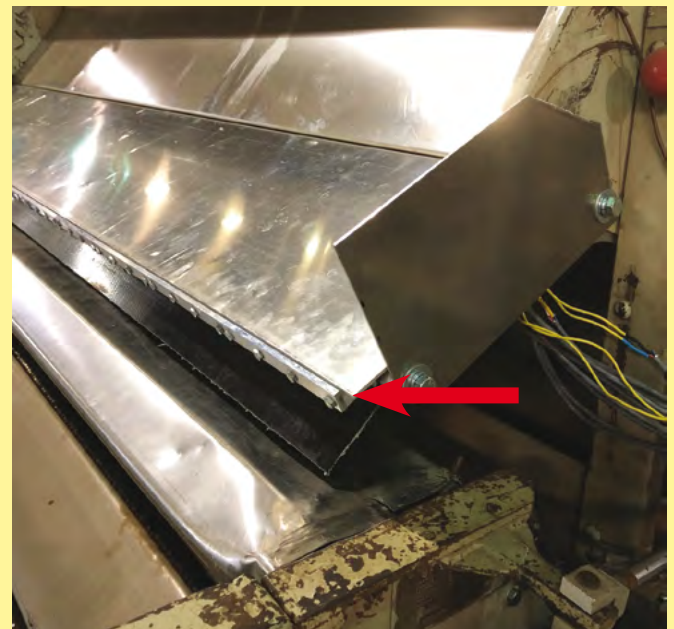
(b) Air knife, at the bottom of the feeder apron, used to create an air blast to eject the detected plastic out of the flow of seed cotton, over the front of the gin stand, onto the floor

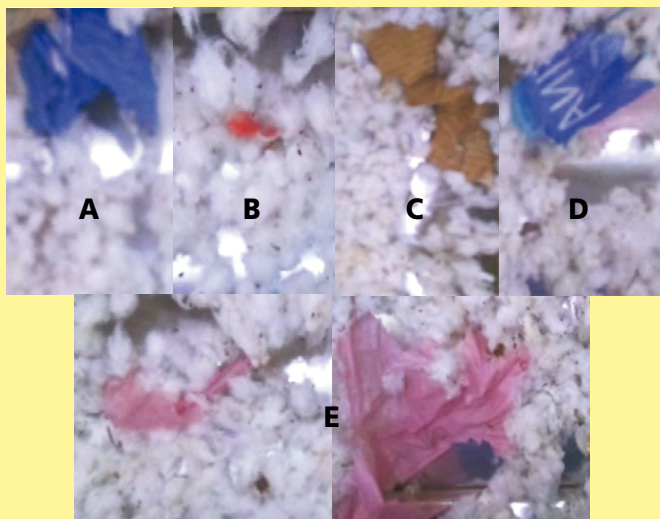
FIGURE 3: Some of the images captured by the cameras, above the feeder apron, used in the VIPR system during ginning at a commercial cotton gin during the 2018–19 ginning season in Meadow, Texas. Images are: A blue plastic module wrap, B seed cotton with red module marker paint on cotton, C brown cardboard inside the module, D plastic wrapper from a water bottle, E pink module wrap.

The processors used in the system can store images of the ‘contaminants’ detected. Some of the items detected at the commercial cotton gin in Meadow, Texas are shown in Figure 3. Included is an image (top left) of seed cotton colored with module marker paint. Even though approved module marker paint is not a contaminant, the system noted the color difference and ejected the seed cotton. We opted to have the system be more aggressive and err on the side of caution by removing all non-cotton items.
